Inspection Report

Dick & Jane Smith 1234 E Main Street Any Town USA 11111

Inspection Table Of Contents

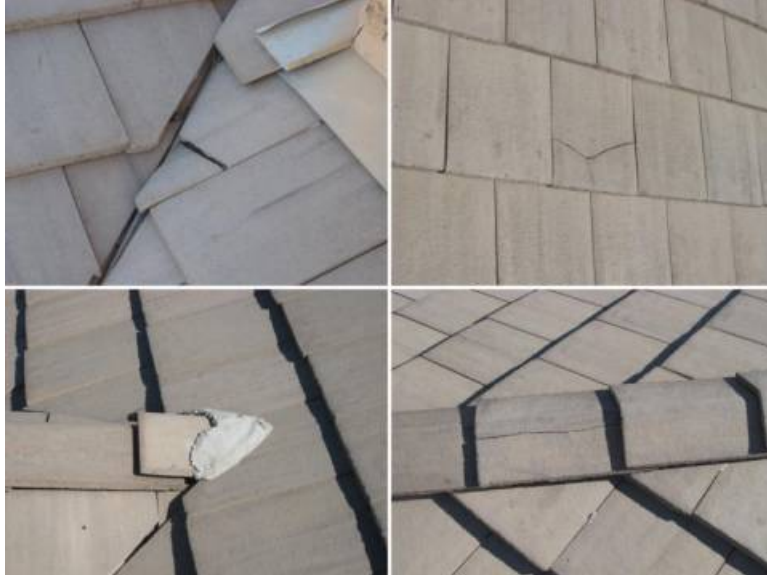
- Roof Covering Type** Concrete tile - These types of roofing systems when correctly installed and maintained have a useful life of over 25 years. Regular maintenance and annual evaluation advised.
- Roof Covering Condition** **Attention** - The following conditions were observed on the tile roof surface. One or more broken, cracked or over chipped roof tiles were observed, replacement is advised. One or more slipped or displaced tiles were observed, resetting of tiles is advised. One or more damaged or cracked mortar packings were observed, replacement is advised. Further client investigation is advised, contact a qualified licensed roofing contractor for further evaluation, comment, or repairs.

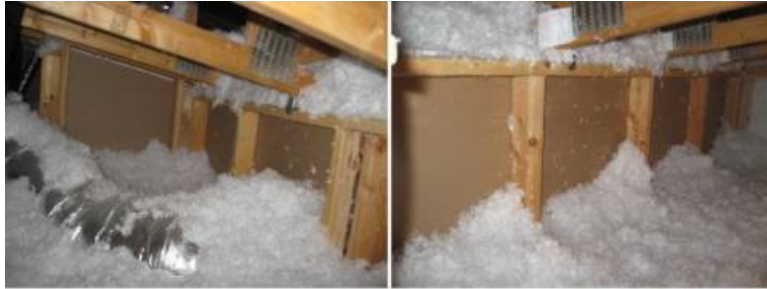
Insulation Vapor Retarder Condition **Attention** - Displaced insulation batts were observed in the attic area in one or more areas. Placing the insulation back into proper position is advised to help with the homes energy efficiency. Further client investigation is advised, contact a qualified licensed contractor for further evaluation, comment, or repairs.

4. **Attention** - Displaced insulation batts were observed in the attic area in one or more areas. Placing the insulation back into proper position is advised to help with the homes energy efficiency. Further client investigation is advised, contact a qualified licensed contractor for further evaluation, comment, or repairs.

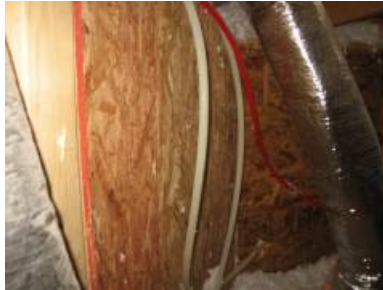
**Visible Plumbing Condition**

Attention - Portions of the water supply piping material are not adequately protected from frost damage, with either the homes installed insulation or pipe insulation. During freezing conditions damage could occur. The addition of pipe insulation is advised. Further client investigation is advised, contact a qualified licensed contractor for further evaluation, comment, or repairs.

5. **Attention** - Portions of the water supply piping material are not adequately protected from frost damage, with either the homes installed insulation or pipe insulation. During freezing conditions damage could occur. The addition of pipe insulation is advised. Further client investigation is advised, contact a qualified licensed contractor

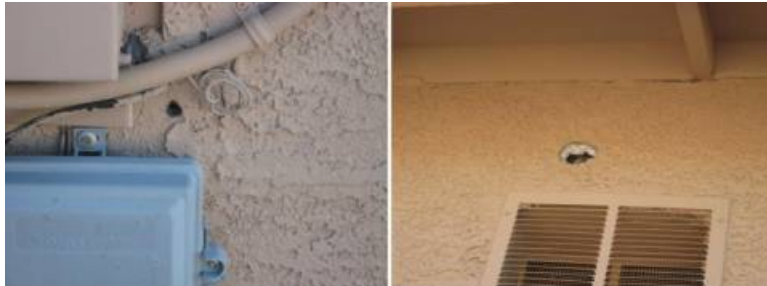
Exterior Stucco Wall Cladding Condition

Attention - The following conditions were observed on the exterior stucco siding. Minor hair line cracking was observed in one or more areas. These cracks are typical of stucco finishes and do not appear to be significant, repairs or filling is optional, further monitoring is advised. Separation cracking was observed in one or more areas, these cracks appear large enough to warrant filling to prevent moisture intrusion. Minor holes were items have been removed from the walls were observed in one or more areas, repairs are advised. Wood pecker damage was observed in one or more areas, repairs are advised. Signs of prior repairs were observed in one or more areas. Further information should be obtained from the seller. Further client investigation is advised, contact a qualified licensed contractor for repairs or to comment further on these conditions.

6. **Attention** - The following conditions were observed on the exterior stucco siding. Minor hair line cracking was observed in one or more areas. These cracks are typical of stucco finishes and do not appear to be significant, repairs or filling is optional, further monitoring is advised. Separation cracking was observed in one or more areas, these cracks appear large enough to warrant filling to prevent moisture intrusion. Minor holes were items have been removed from the walls were observed in one or more areas, repairs are advised. Wood pecker damage was observed in one or more areas, repairs are advised. Signs of prior repairs were observed in one or more areas. Further information should be obtained from the seller. Further client investigation is advised, contact a qualified licensed contractor for repairs or to comment further on these conditions.

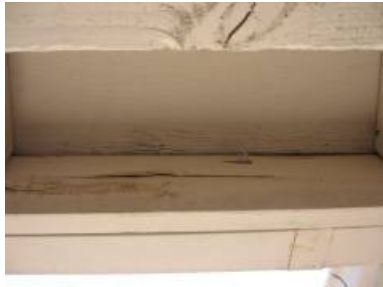
Soffit Eaves Condition

Attention - Signs of staining or moisture damage were observed in one or more areas. Further client investigation is advised, contact a qualified licensed contractor for repairs or to comment further on these conditions.

8. **Attention** - Signs of staining or moisture damage were observed in one or more areas. Further client investigation is advised, contact a qualified licensed contractor for repairs or to comment further on these conditions.

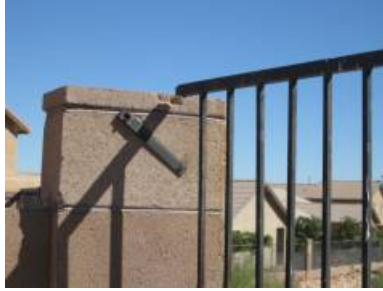
cap blocks is loose and needs repair. Further client investigation is advised, contact a qualified licensed contractor for repairs or to comment further on these conditions.

14. **Attention** - One or more of the wrought iron panels is damaged and needs repair. One or more of the wrought iron fence panels is loose and needs repair. One or more of the cap blocks is loose and needs repair. Further client investigation is advised, contact a qualified licensed contractor for repairs or to comment further on these conditions.

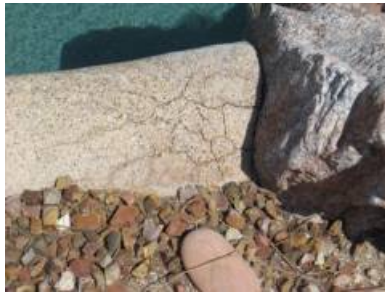
Attention - Damage to the exposed rolled beam was observed in one or more areas, repairs are needed, further evaluation is advised. Damage to the interior finish was observed in one or more areas, resurfacing may be needed, further evaluation is advised. Staining of the interior finish was observed in one or more areas. These stains may or may not be removable with an acid wash. Further client investigation is advised. Contact a qualified licensed pool contractor for further evaluation, repairs or to comment further on these conditions.

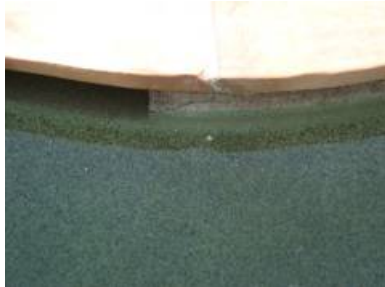
Attention - Calcium mineral deposits were observed at the water line. These deposits may or may not be removable. Further client investigation is advised. Contact a qualified licensed pool contractor for further evaluation, repairs or to comment further on these conditions.

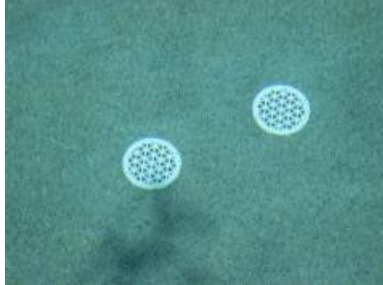
Attention - The deep end drain cover(s) are an older style of flat cover which can pose an entrapment hazard. Replacement with a new domed anti vortex style cover is advised to reduce the risk of a child or person becoming en-trapped on the drain cover. Repairs are advised for safety. Further client investigation is advised. Contact a qualified licensed pool contractor for further evaluation, repairs or to comment further on these conditions.

1. **Attention** - The deep end drain cover(s) are an older style of flat cover which can pose an entrapment hazard. Replacement with a new domed anti vortex style cover is advised to reduce the risk of a child or person becoming en-trapped on the drain cover. Repairs are advised for safety. Further client investigation is advised. Contact a qualified licensed pool contractor for further evaluation, repairs or to comment further on these conditions.

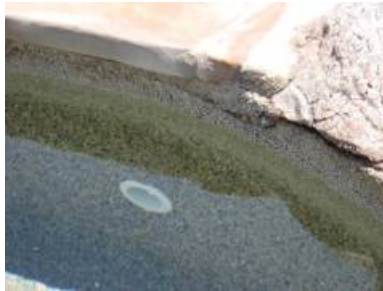
Attention - The pool light did not function using normal controls. The inspector is unable to determine if this is an issue with the bulb, fixture housing, GFCI or switch. Further client investigation is advised. Contact a qualified licensed pool contractor for further evaluation, repairs or to comment further on these conditions.

2. **Attention** - The pool light did not function using normal controls. The inspector is unable to determine if this is an issue with the bulb, fixture housing, GFCI or switch. Further client investigation is advised. Contact a qualified licensed pool contractor for further evaluation, repairs or to comment further on these conditions.

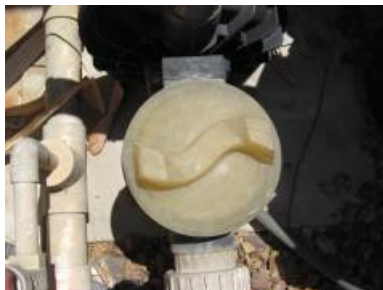
Attention - The cover at the secondary catch basket located at the circulation pump head could not be removed using normal hand strength, the condition of the basket and interior is not known. The unit appears to be halfway or more through its useful service life. Circulation motors have an expected life of 7-10 years by industry standards depending on the amount of use and maintenance. Further client investigation is advised. Contact a qualified licensed pool contractor for further evaluation, repairs or to comment further on these conditions.

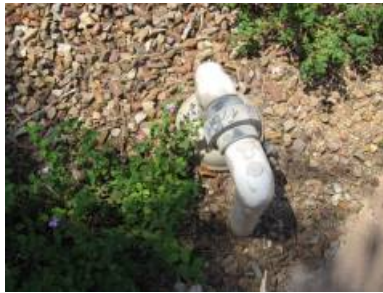
Attention - Sun rot damage was observed in one or more areas at the visible plumbing lines, painting is advised to prevent further deterioration. Portions of the visible PVC piping are not properly painted to prevent UV damage, painting is advised to prevent sun damage. Further client investigation is advised. Contact a qualified licensed pool contractor for further evaluation, repairs or to comment further on these conditions.

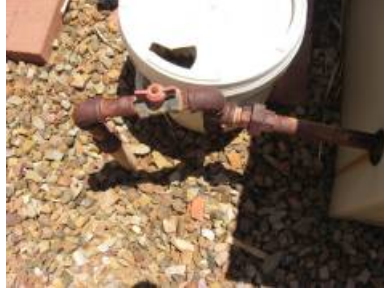
Attention - The gas hard pipe is rusted and needs maintenance. Further client investigation is advised. Contact a qualified licensed pool contractor or qualified trades person for repairs, replacement or to comment further on these conditions.

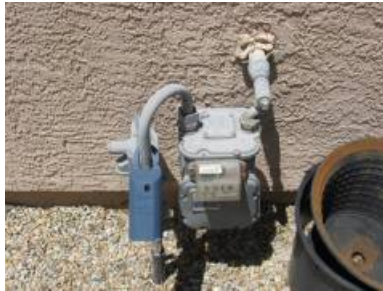
Meter Shutoff Location The meter and gas shut off is located on the north side of the home or property.

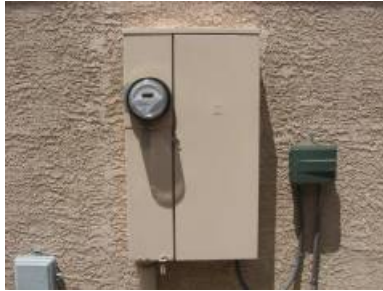
The main electric panel and disconnect are located on the north side of the home or property.

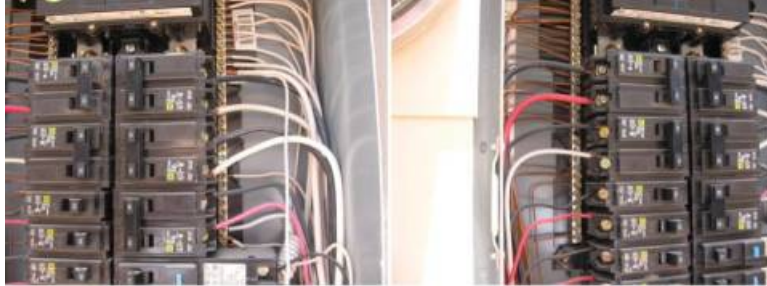
Branch Circuit Conductor Condition **Attention** - A white wire connected to a breaker was observed in one or more locations. White is reserved for neutral only, proper color coding is advised. Further client investigation is advised, contact a qualified licensed electrical contractor for repairs or to comment further on these conditions.

4. **Attention** - A white wire connected to a breaker was observed in one or more locations. White is reserved for neutral only, proper color coding is advised. Further client investigation is advised, contact a qualified licensed electrical contractor for repairs or to comment further on these conditions.

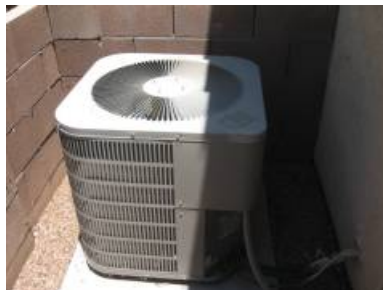
Ground Set -

Type	Central air conditioning - Forced air electric powered split unit - exterior condenser, interior evaporator coils. Central air conditioning units have an expected life of 15-20 years by industry standards. For optimum performance the cooling equipment should be fully serviced annually by a qualified licensed HVAC contractor. Information regarding the units prior repairs and maintenance should be obtained from the current home owner. If annual service has not be performed within the past 12 months, consideration should be given to having the unit (s) fully serviced prior to close of escrow.
Manufacture Date	Date - 2008.
Unit Operation Condition	Functional - The unit functioned at the time of the inspection and produced cooled air. The unit appears to be halfway or more through it's useful service life. Split AC units have an expected life of 15-20 years by industry standards.
Evaporator Condenser Coils Condition	Attention - Air is escaping from around the refrigerant lines or evaporator A-coil compartment. Sealing with foil tape is advised to prevent the loss of conditioned air. Further client investigation is advised, contact a qualified licensed HVAC contractor for repairs or to comment further on these conditions.

Refrigerant Lines Condition	Attention - The insulation wrap for the exterior portion of the refrigerant line to the condenser needs replacement. Further client investigation is advised, contact a qualified licensed HVAC contractor for repairs or to comment further on these conditions.
Electrical Condition	Attention - A missing knockout was observed at the electrical disconnect box, proper capping with a knockout cover is advised for safety. Further client investigation is advised, contact a qualified licensed HVAC contractor for repairs or to comment further on these conditions.

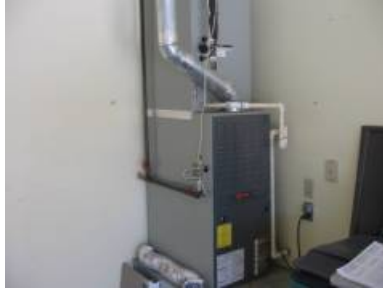
Condensate Drain Condition	Functional - The condensate line is properly installed. Depending on the time of year and relative humidity condensation may or may not be seen flowing from the drain line. Annual cleaning and maintenance is needed to insure proper drainage.
Supply Air Temperature	Degrees - 54.
Return Air Temperature	Degrees - 76.
Air Temperature Differential	Functional - The temperature differential is acceptable.
Filter Condition	See information under heating air handler.
Distribution System Type	Installed ducts and louvered air registers -
Distribution System Condition	See information under heating air handler.
Cooling Source In Each Habitable Room	Functional - There is a source of cooling in each of the inhabitable rooms.
Thermostat Operating Controls Condition	See information under heating air handler.
Heating Air Handler	
Location	Garage -

Type	Forced air natural gas - Forced air gas heating units have an expected life of 20-25 years by industry standards. For optimum performance the heating equipment should be fully serviced annually by a qualified licensed HVAC contractor. Information regarding the units prior repairs and maintenance should be obtained from the current home owner. If annual service has not be performed within the past 12 months, consideration should be given to having the unit (s) fully serviced prior to close of escrow.
Manufacture Date	Date - 2008.
Unit Operation Condition	Functional - The unit functioned at the time of the inspection and produced heated air. The unit appears to be halfway or more through it's useful service life. Forced air gas heating units have an expected life of 20-25 years by industry standards.
Heat Exchanger-Burner	Functional - This inspection covers only the readily visible portions.

Flues Vents Condition	Attention - There is not adequate clearance from the flue pipe to the drywall ceiling. By current standards there should be a minimum of 1 inch clearance with a metal fire stop fitting. Repairs are advised. Further client investigation is advised, contact a qualified licensed HVAC contractor for repairs or to comment further on these conditions.
Combustion Air Condition	Functional - Availability of secondary air for combustion and relief appears adequate.
Blower Condition	Attention - The blower components and compartment are dirty. This is an indication that unfiltered air has been entering into the air handler and the conditioned air supply, cleaning and servicing are advised. Further client investigation is advised, contact a qualified licensed HVAC contractor for repairs or to comment further on these conditions.
Automatic Safety Controls Condition	Functional - The units automatic safety override controls are properly installed, testing and operation of the installed systems is beyond the scope of the inspection.

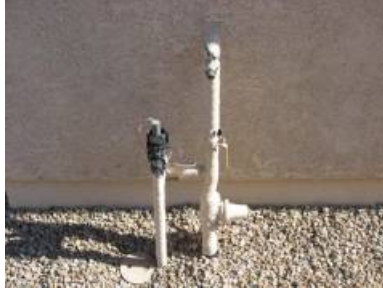
Main Water Shutoff Location	North side of home - Shut off valves are not operated during the inspection
------------------------------------	---

Attention - The main water meter valve box was congested with debris, clearing is advised for proper access to the meter and main shut off. Further client investigation is advised. Contact a qualified licensed plumbing contractor for repairs or to comment further on these conditions.

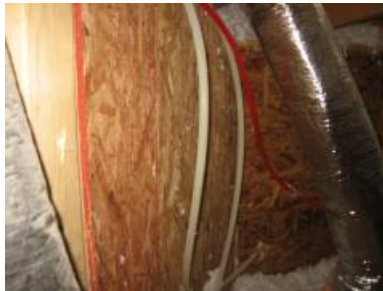
Attention - Portions of the interior supply distribution piping are not adequately protected from frost damage, during freezing conditions damage could occur. Properly insulating all exposed piping, fixtures and regulators in unconditioned areas such as garages, carports, patios, utility and laundry rooms, exterior walls, pool areas, attics, crawlspaces and roof surfaces is advised to help prevent damage during freezing conditions. Repairs are advised.

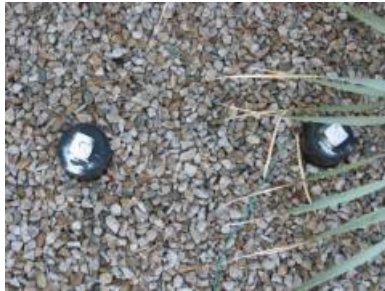
Pressure Regulator Condition	There is a water pressure regulator connected to the homes incoming water supply line. The accuracy of the unit is outside the scope of the inspection.
Sewer Cleanout Location	East side of the home. Sewer lines can not be inspected by visual means during a home inspection. Client is advised waste lines and vent stacks should be video scoped to located possible damage, collapse or obstructions like tree roots, this is especially necessary for waste lines and vent stacks older then 10 years or in areas with heavy vegetation. Video scoping should be performed within your inspection period as a plumbing specialist may discover issues requiring costly repairs.
Sewer Cleanout Condition	Attention - The ABS sewer clean out caps and exposed connections are in need of painting to help prevent damage from the suns UV rays. Painting is advised. Further client investigation is advised. Contact a qualified licensed plumbing contractor for repairs or to comment further on these conditions.

Water Filtration Type	There is a water softener, conditioner, RO system or filter installed. The inspector only notes the presence of the unit / units. The Arizona Standards of Professional Practice does not cover these systems and are not covered by this report or contract. Further information concerning the units operation, maintenance and prior service should be obtained from the seller or a licensed contractor.
Recommend	Recommend - Due to the conditions listed above under the section Plumbing Systems further investigation by the client is advised. Contact a qualified licensed plumbing contractor, for further evaluation, repairs, cost estimates, or to comment on the conditions listed and your repair options. Additional repairs may be necessary for the safe and proper operation of these systems and to insure the occupants of the home are safe. Services should be performed within your inspection period, as a specialist may identify additional defects, conditions, or recommend upgrades that could effect the evaluation of the component.

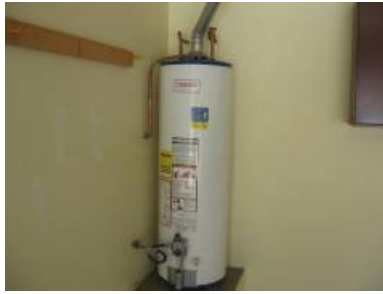
Garage -

Natural gas storage tank water heater. Storage tank water heaters have an expected life of 10-15 years by industry standards. For optimum performance the water heating equipment should be fully serviced annually by a qualified licensed plumbing contractor. Information regarding the units prior repairs and maintenance should be obtained from the current home owner. If annual service has not be performed within the past 12 months, consideration should be given to having the unit (s) fully serviced prior to close of escrow.

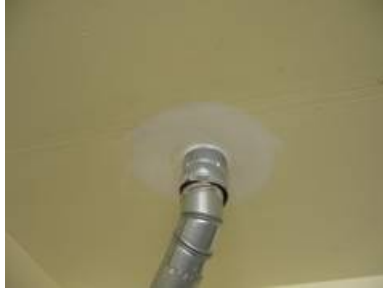
Attention - There is not adequate clearance from the flue pipe to the drywall ceiling. By current standards there should be a minimum of 1 inch clearance with a metal fire stop fitting. Repairs are advised when the water heater is next replaced. Further client investigation is advised. Contact a qualified licensed plumbing contractor for repairs or to comment further on these conditions.

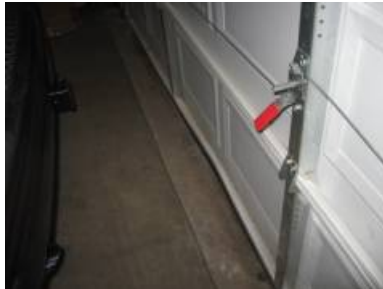
Overhead Door Type	Two car - The automatic overhead door was raised and lowered using the wall mount controller.
Overhead Door Opener Condition & Operation	Attention - One or more of the overhead door panels are bent or damaged, the damage is cosmetic and does not impact the doors operation. The lower rubber door seal needs replacement to prevent moisture or pests from entering the garage. Further client investigation is advised. Contact a qualified licensed overhead door contractor for repairs or to comment further on these conditions.

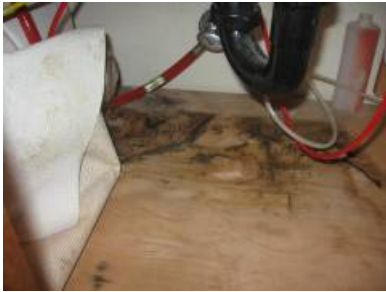
Caulking Condition	Attention - Caulking repairs are advised in the following locations to prevent moisture intrusion. Around the perimeter of the counter back or side splash.

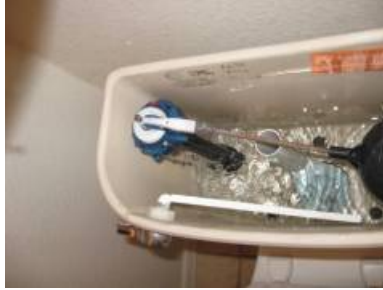
Fixtures Faucets Condition	Attention - The aerator is congested with mineral deposits and needs clearing or replacement to improve the spray pattern and flow. Further buyer investigation is advised. Contact a licensed plumbing contractor for repairs or to comment further on these conditions.
Countertops Condition	Functional - The countertops are in serviceable condition.
Cabinets Storage Condition	Functional - The cabinets are in serviceable condition.
Toilet Condition	Attention - The interior components of the toilet are in poor condition and need replacement. Further buyer investigation is advised. Contact a licensed plumbing contractor for repairs or to comment further on these conditions.

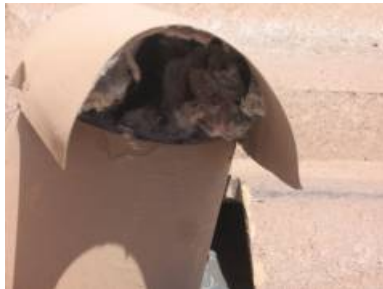
Washer Connection Condition	Functional - No visible signs of leaking were observed at the hot and cold water shut offs.
Dryer Connection Type	There is a gas supply line, shut off, exhaust ventilation, 110 volt and 220 volt electrical receptacle provided for either a gas or electric cloths dryer. 220 receptacles are not tested for proper wiring configuration. Appliances are not inspected, they should tested by the client or their agent.
Fuel Distribution Support Condition	Functional - The fuel distribution piping, flex line connector and shut off are properly supported and in serviceable condition.
Dryer Ventilation Condition	Attention - The cloths dryer ventilation duct is congested with lint debris and needs cleaning prior to use, a vent congested with lint can reduce the units efficiency and create a fire hazard. Clearing is advised. Further client investigation is advised, contact a qualified licensed contractor for repairs or to comment further on these conditions.

10. **Attention** - The cloths dryer ventilation duct is congested with lint debris and needs cleaning prior to use, a vent congested with lint can reduce the units efficiency and create a fire hazard. Clearing is advised. Further client investigation is advised, contact a qualified licensed contractor for repairs or to comment further on these conditions.
